NACA RM E56H06

RESEARCH MEMORANDUM

TURBINE FAILURE INVESTIGATION OF J65-W-4 TURBOJET ENGINE IN AN ALTITUDE TEST CHAMBER

By John E. McAulay, Willis M. Braithwaite, and Carl C. Ciepluch

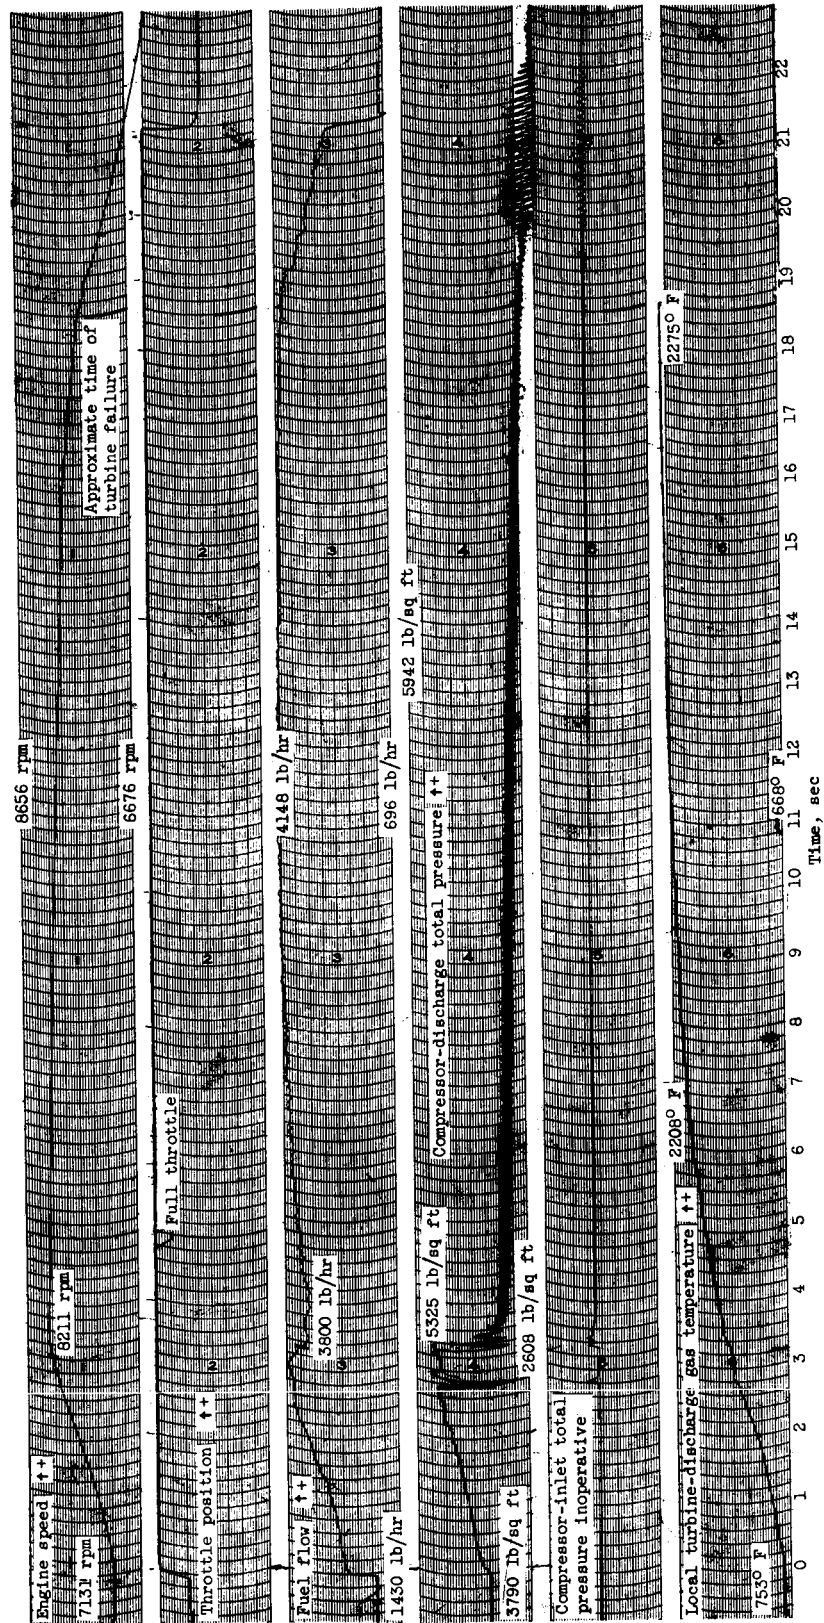
Description of turbine-failure throttle burst. - Since a phenomenon had been found that might result in turbine failure and the conditions had been determined at which it occurred, it was necessary to demonstrate that this phenomenon would cause turbine failure and that this failure was typical of those in service. Consequently, at an altitude of 35,000 feet, a flight Mach number of 0.54, and an inlet-air temperature of -40° F, a throttle burst was made from about 85 percent rated mechanical engine speed. Once the throttle had been moved to the full military position, it was held in a fixed position after the stall occurred. The time history of important engine parameters during this throttle burst is presented in figure 9. The engine acceleration proceeded in a normal fashion for approximately $2\frac{3}{4}$ seconds when 1 cycle of

compressor surge occurred at about 97 percent of rated engine speed. By the time the compressor recovered, the engine had accelerated to about 98 percent of rated engine speed and the top-speed governor of the fuel control began to reduce fuel flow. However, at 99 percent speed the compressor stalled and did not recover. Because the engine started to decelerate after stall had occurred, the fuel control increased the fuel flow back up to the previous high level along the engine acceleration schedule. As previously stated, the engine fuel-air ratio reached a value of about 0.05 during complete stall. The turbine-discharge gas temperature, as indicated in figure 9, peaked at about 2300° F. The turbine-inlet temperature was considerably above 2300° F. After approximately $18\frac{1}{2}$ seconds from the initiation of the throttle burst, the turbine failed.

Figure 9. - Oscillogram of engine acceleration encountering surge and stall and resulting in turbine failure. Altitude, 35,000 feet; Mach number, 0.54; inlet-air temperature, -40° F.

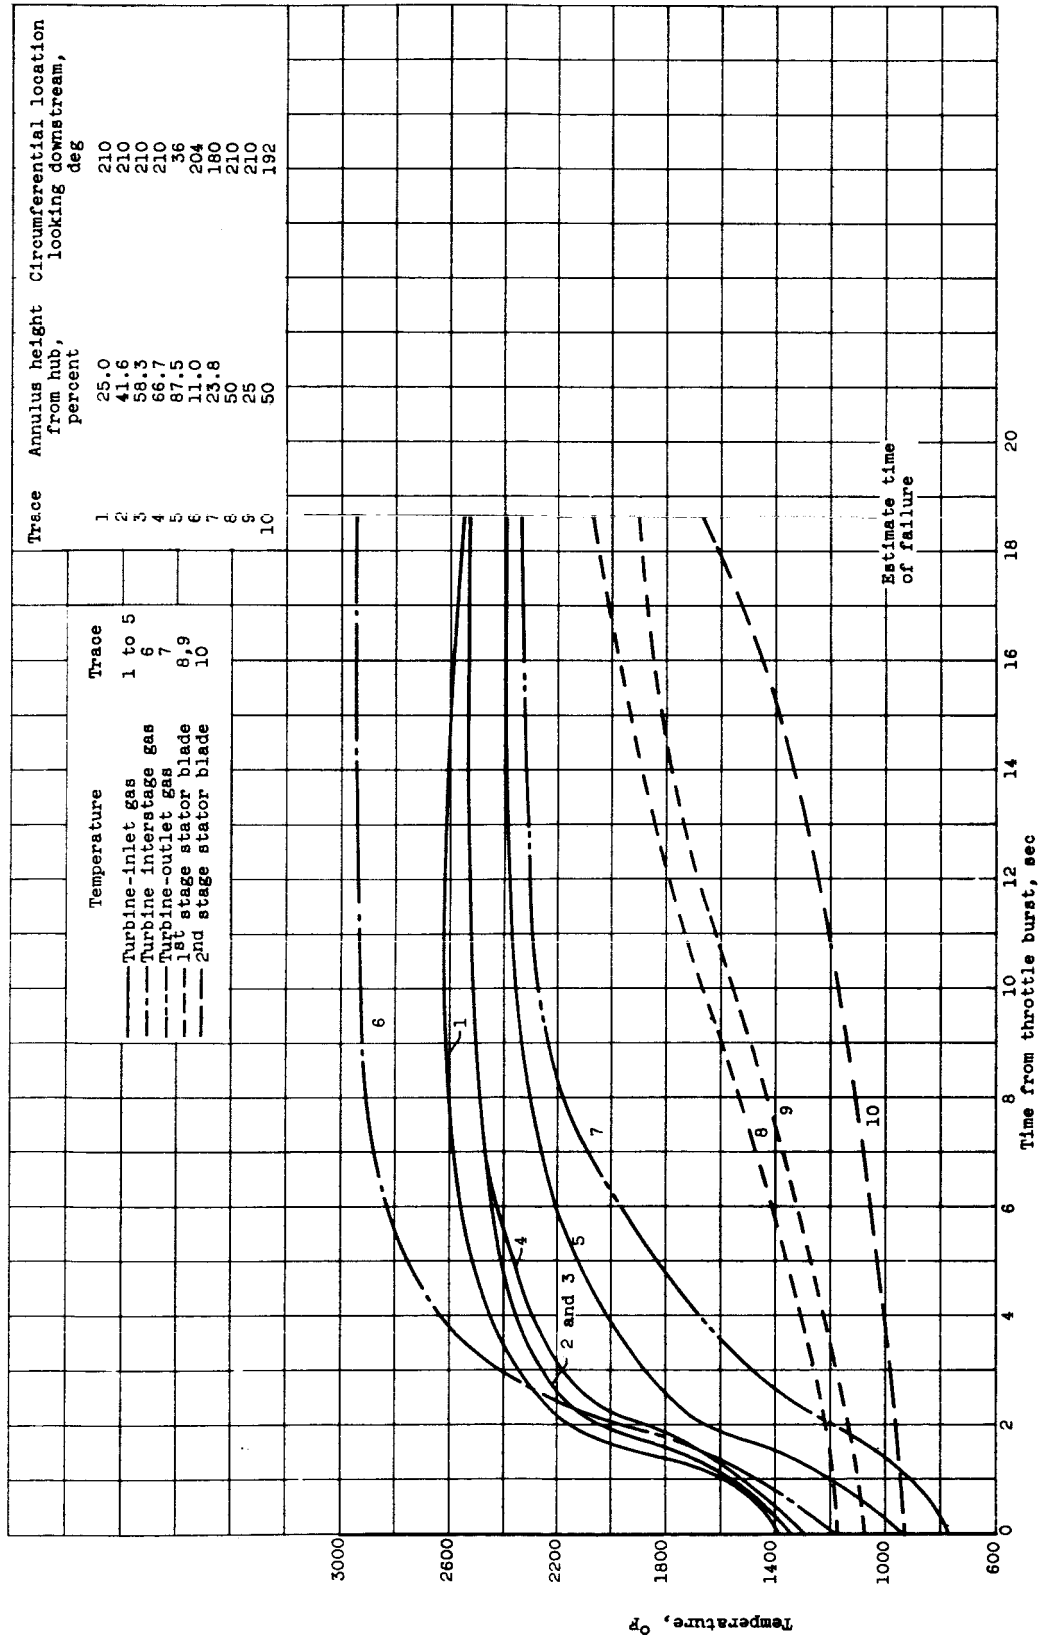
The temperature levels through the turbine during this transient are presented in figure 10. All the lines representing temperatures were obtained from a transient record other than that shown on figure 9 but obtained concurrently with it. The actual measured values of temperature are recorded in figure 10. However, it was estimated that during stall the turbine-inlet and interstage gas temperatures, primarily because of radiation errors, read about 600° and 300° F too low, respectively. Thus, these data indicated that local turbine-inlet gas temperatures rose to about 3200° F shortly after the compressor encountered stall. The lag of the metal temperatures as compared with the gas temperatures is associated with the blade time constants.

Figure 10. - Time history of turbine temperatures during failure run. Altitude, 35,000 feet; flight Mach number, 0.54; inlet-air temperature, -400 F.

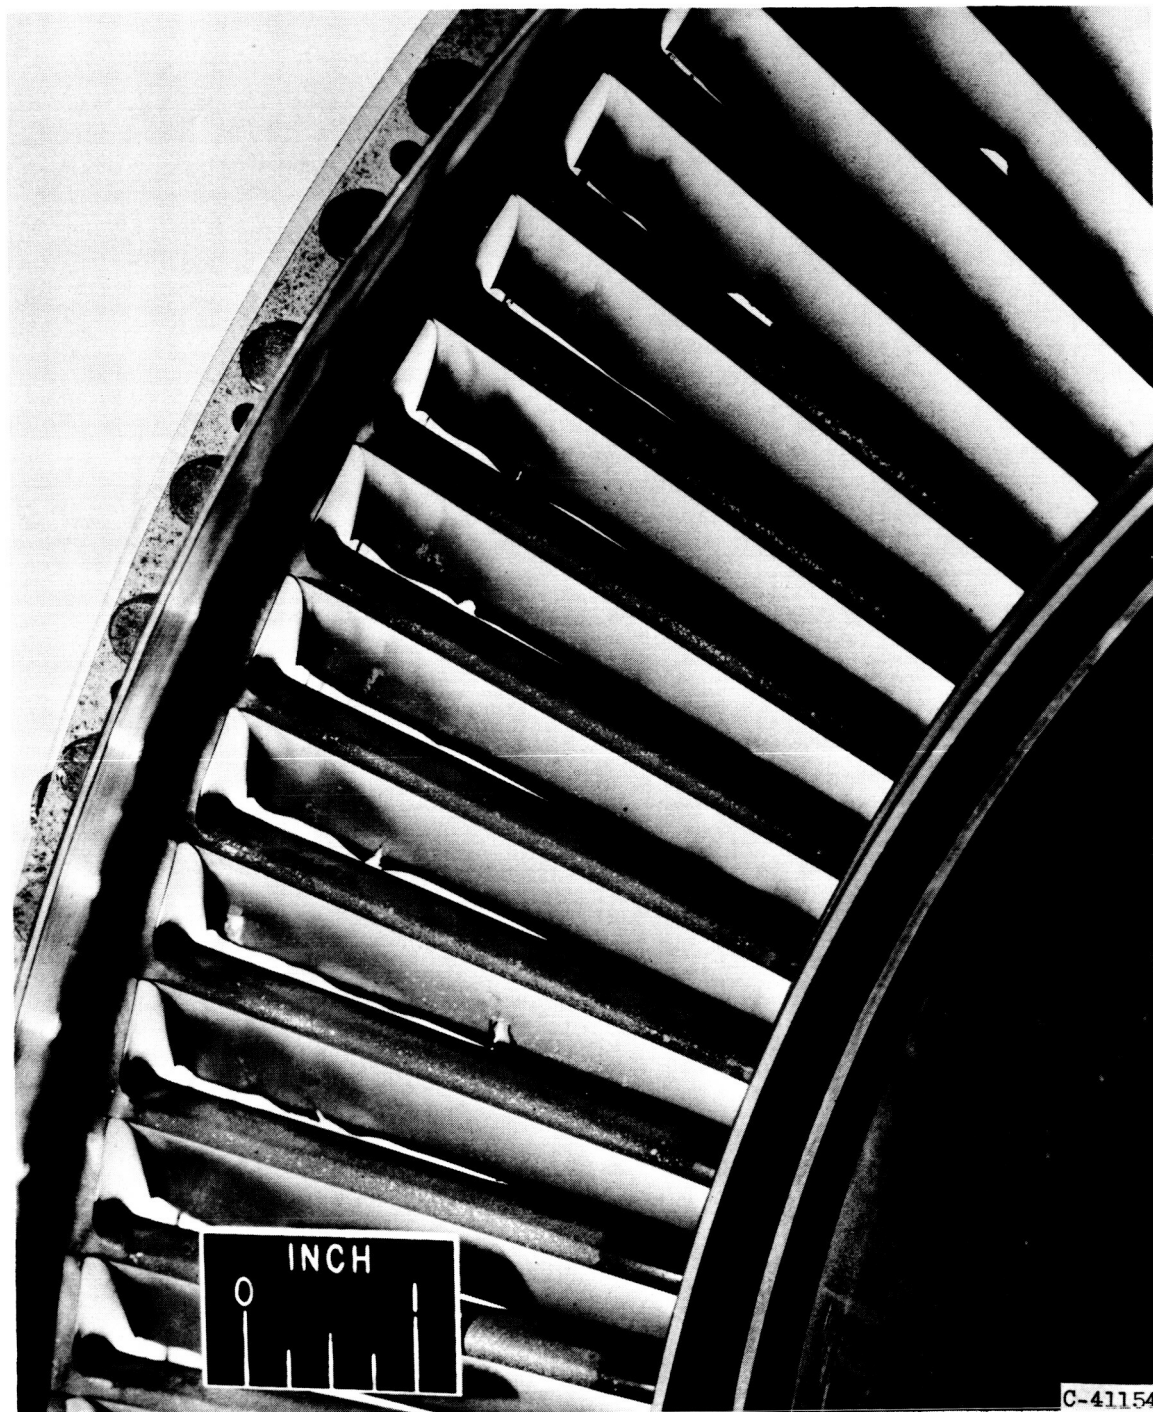
(a) Leading edge of first-stage stator.

Appearance of failed turbine. - The photographs of the first-stage turbine stator, shown in figures 11(a) and (b), indicate that damage to these blades is confined to the trailing edges, where a number of blades suffered minor projectile damage. A portion of the first-stage rotor-blade row is shown in figure 11(c). This photograph clearly shows that these blades stretched and cracked, particularly at mid-span, before the blade tips separated from the rest of the blade.

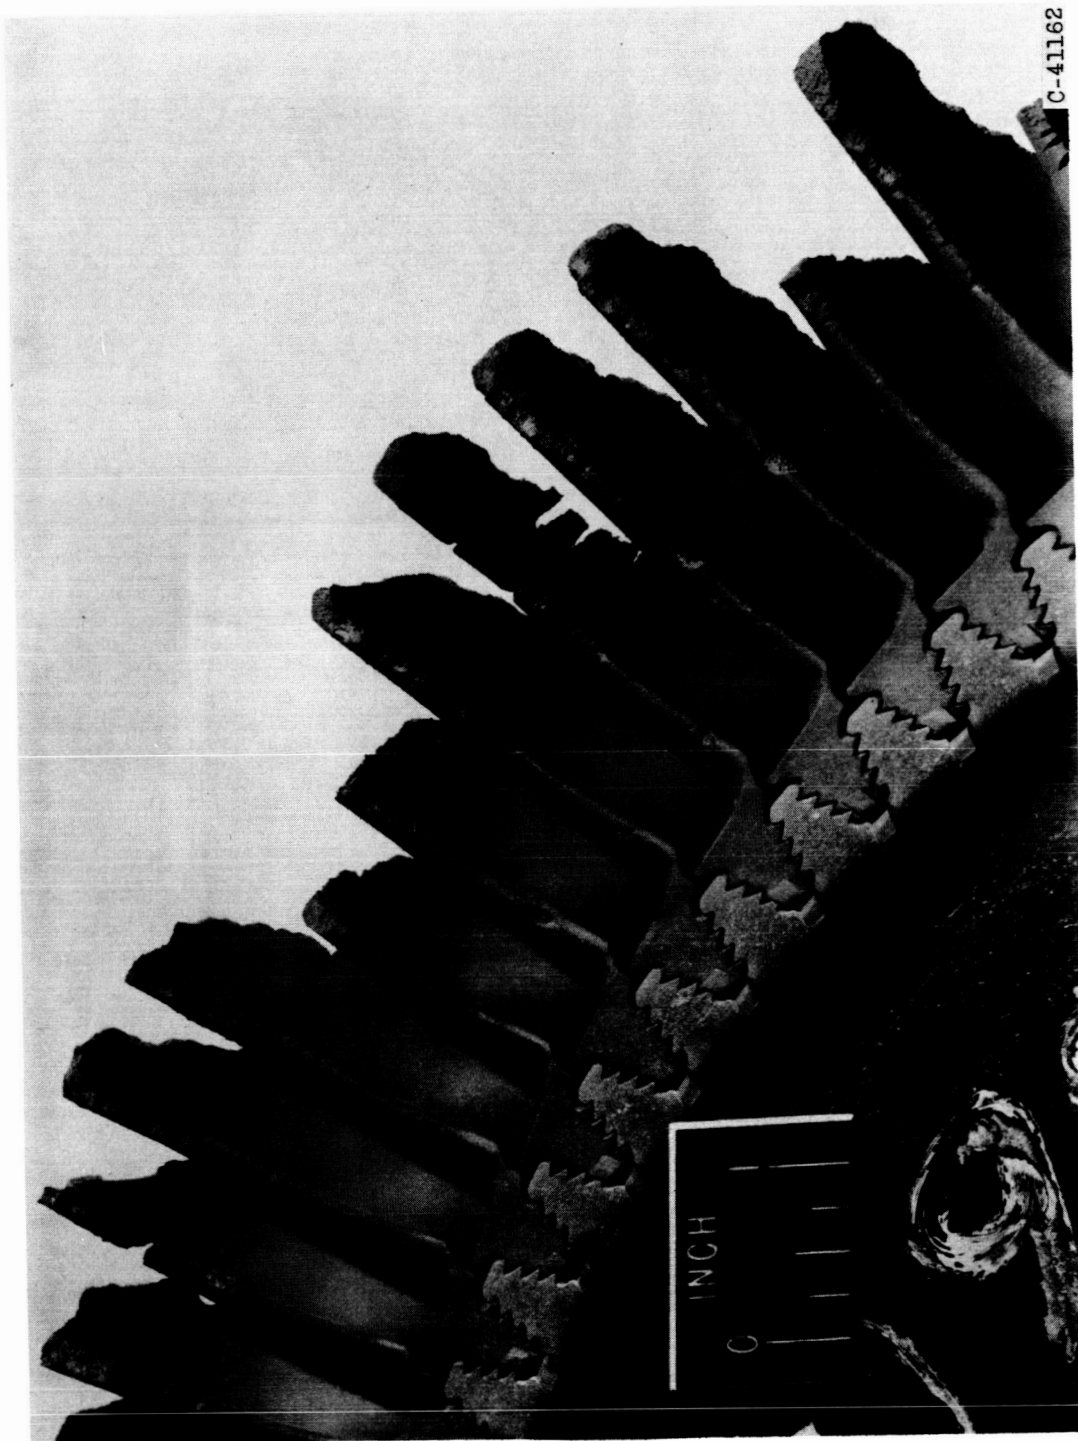
(c) Leading edge of first-stage rotor.

Turbine-failure analysis. - A metallurgical analysis of the failed blades and the metal deposited downstream of the first-stage rotor indicated that the first-stage stator- and rotor-blade temperatures at the time of failure were about 2150° and 2300° F, respectively. The analysis also indicated that the first-stage rotor-blade failure occurred when the metal temperature was sufficiently high to weaken the blades in the grain boundaries. This weakening of the blades in conjunction with the blade stress resulted in failure.

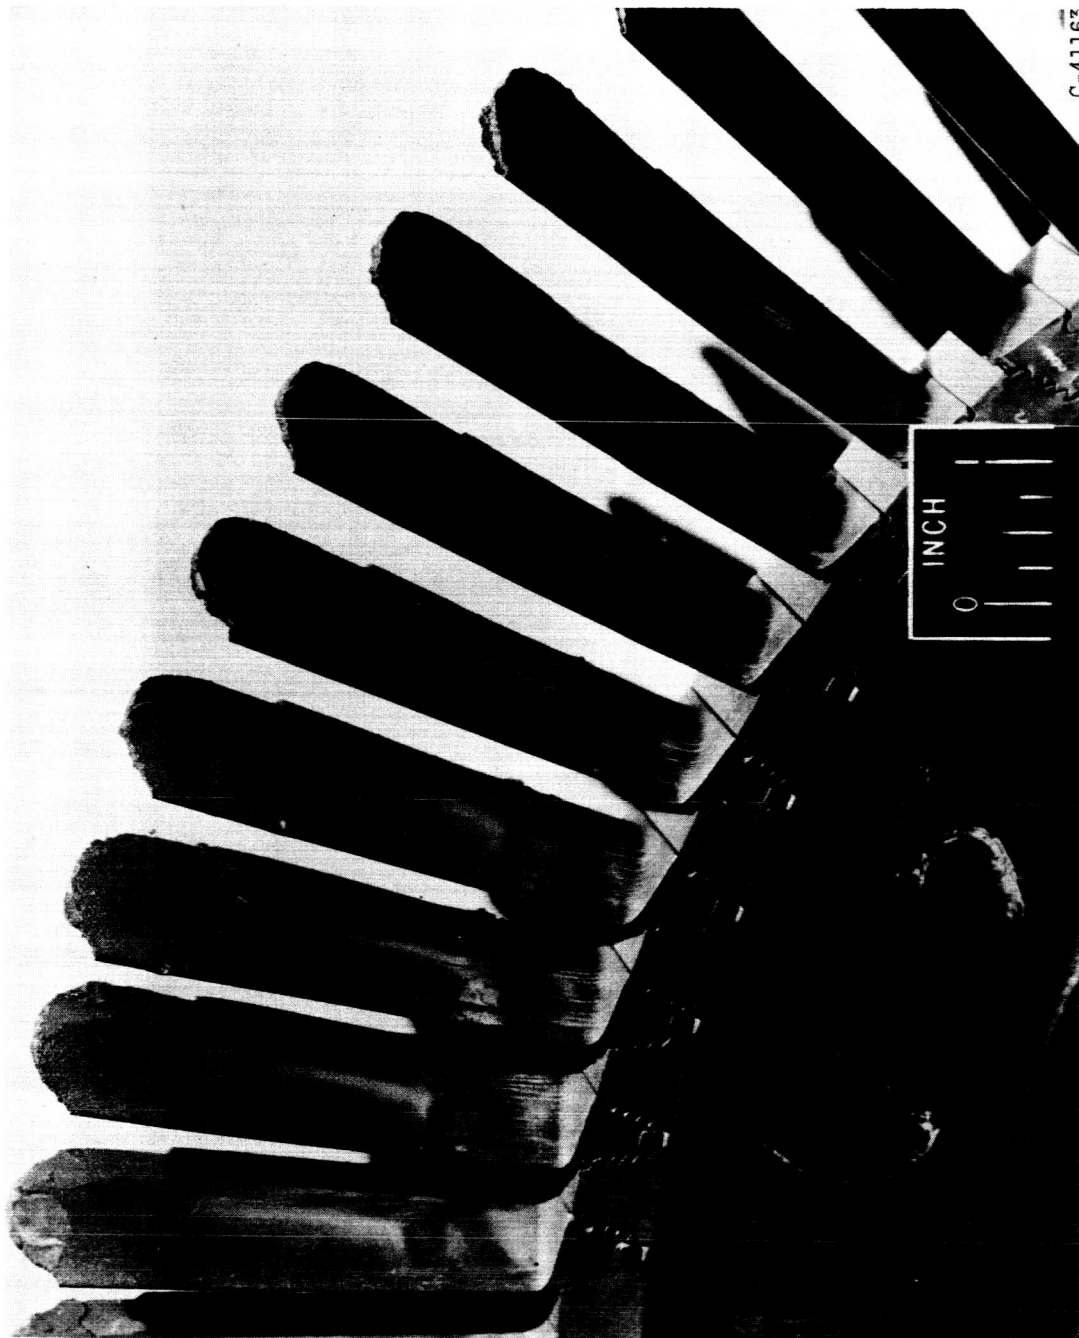
(d) Trailing edge of second-stage rotor.

The second-stage rotor and stator, which are shown in figures 11(d) and (e), respectively, show a large amount of metal deposited on the blades. Also, the tips of the second-stage rotor blades are rounded off, undoubtedly a result of the metal from the first-stage blades coming in contact with the second-stage blades.

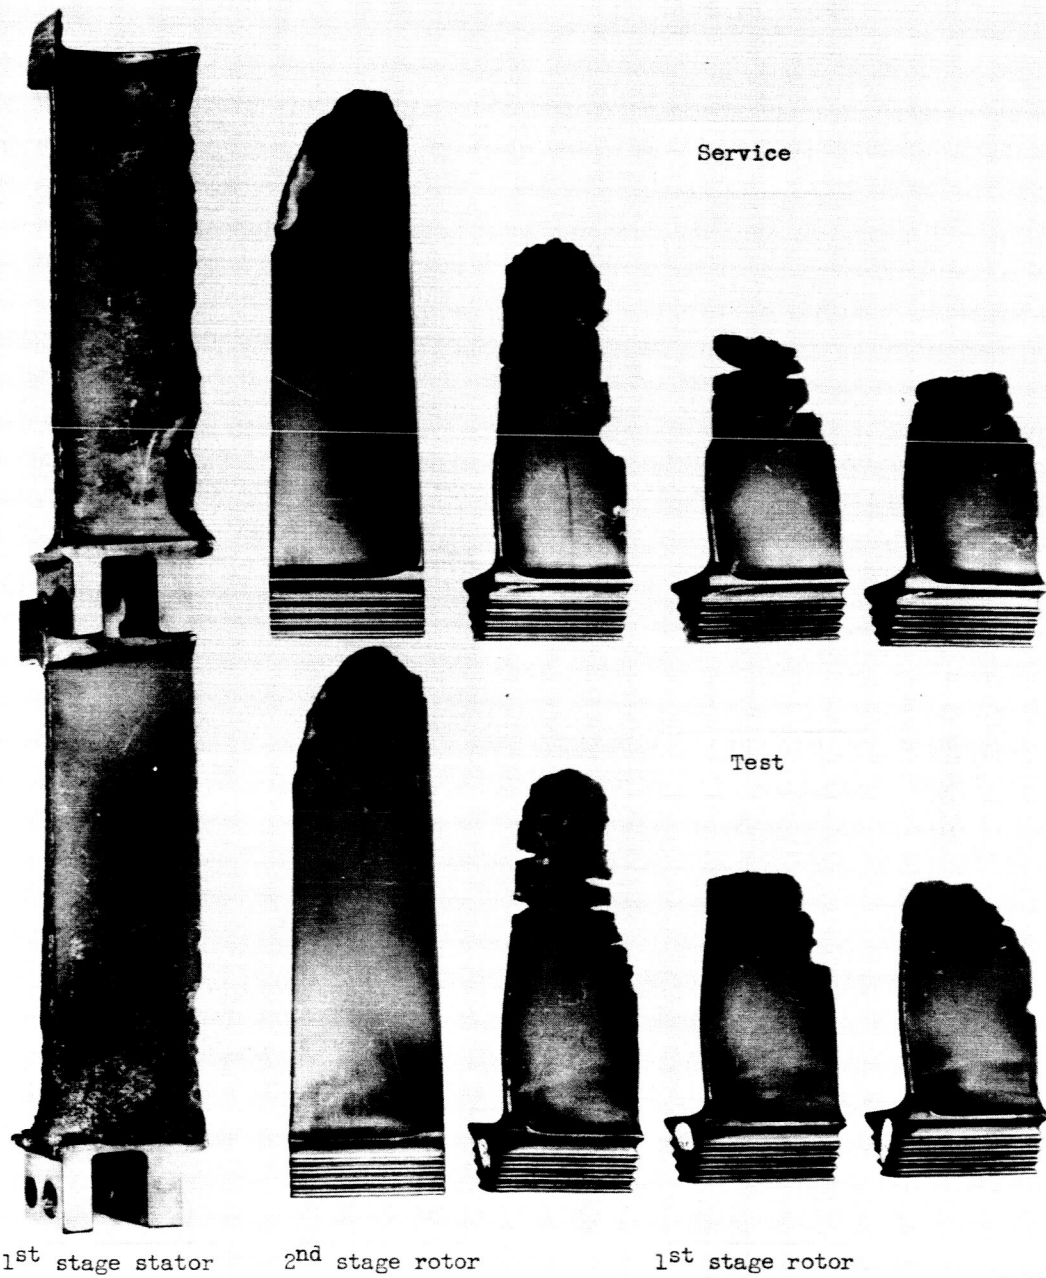
Comparison of service and test failures. - Photographs of typical turbine blades from a service failure and a test failure are presented in figure 12. Shown on the figure from left to right are a first-stage stator, a second-stage rotor, and three first-stage rotor blades. The similarities between the two sets of blades are quite striking, even to the location of metal deposits on the leading edge of the second-stage rotor blades. Representatives of both the engine and airframe

manufacturers accepted these similarities as proof that hang-up compressor stall is the mechanism by which the service failures occurred.

Figure 12. - Typical stator and rotor blades from test failure and service failure.

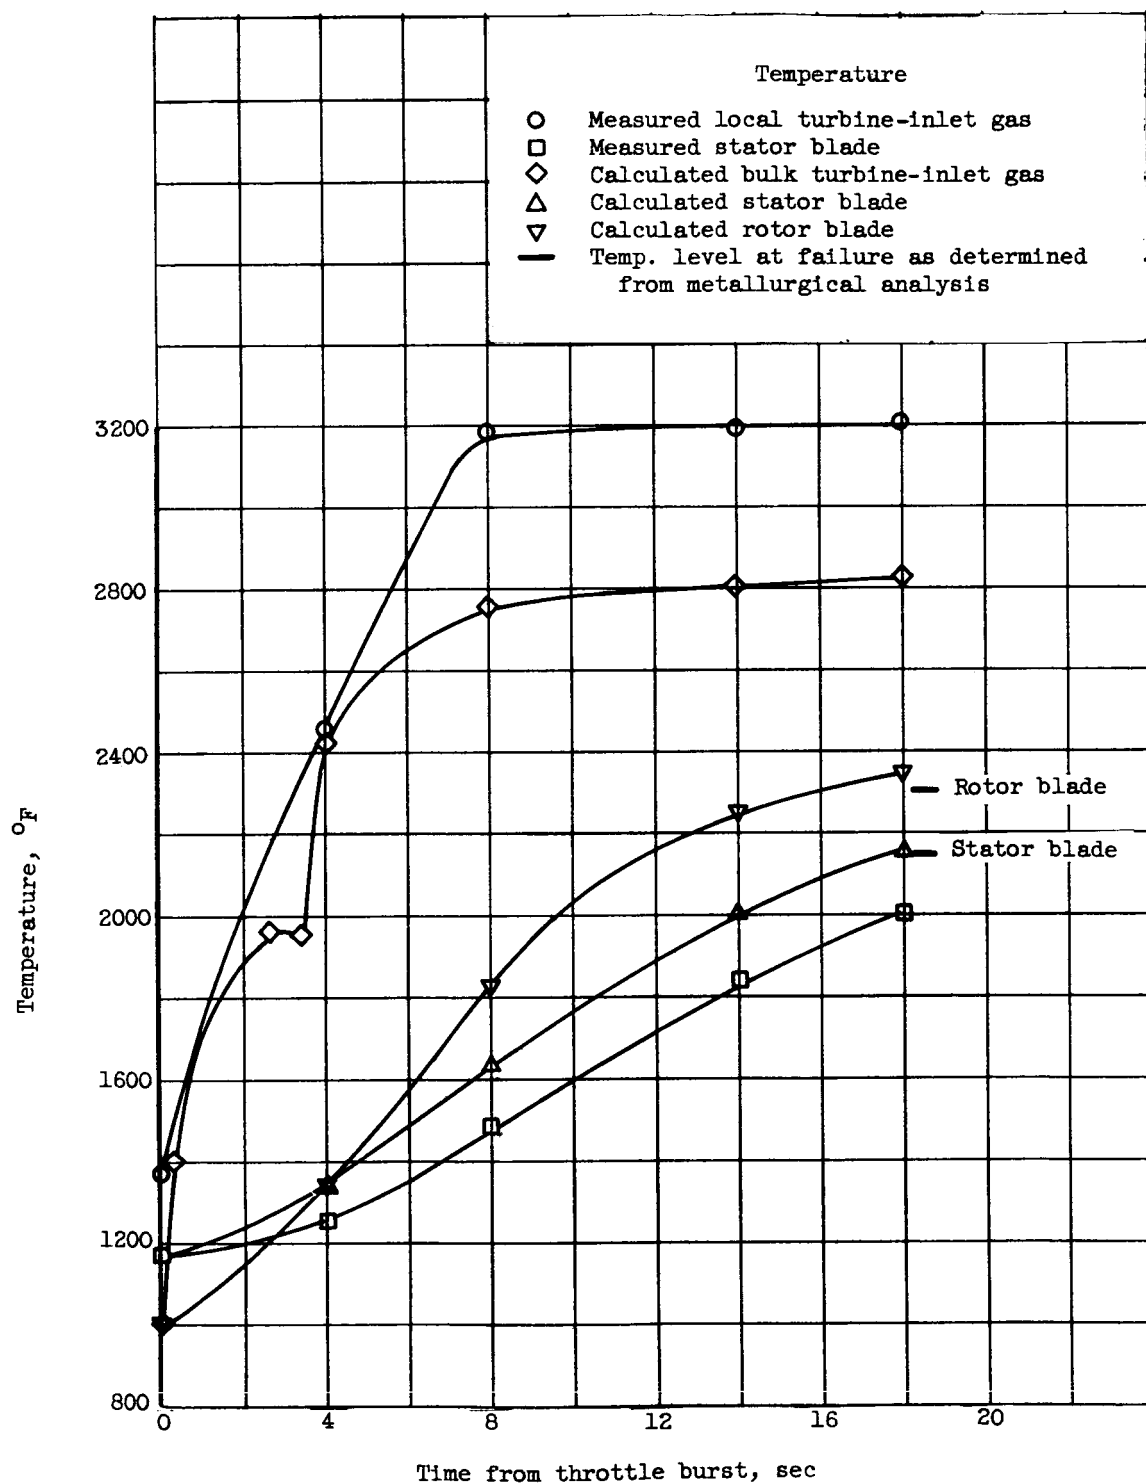
Blade temperature analysis. - The data presented in figure 13 show the variation of measured and calculated turbine-inlet gas temperature, measured and calculated stator-blade temperature, and calculated rotor-blade temperature with time as measured from the initiation of the failure throttle burst of figure 10. The measured turbine-inlet gas temperature shown on this figure is the same as that presented in figure 11, except that it has been corrected for radiation effects. The calculated blade temperatures were obtained by approximating the blade heat-transfer coefficient and time constant, where the time constant is a function of the heat-transfer coefficient and the blade material and geometry. Also shown on the figure are the metal temperatures of the first-stage stator and rotor blades as estimated from the metallurgical analysis discussed in the previous paragraph.

All three methods of obtaining the blade temperature of the first-stage stator at the point of turbine failure show reasonably close agreement. The highest value of 2150° F and the lowest value of 2000° F were obtained by a metallurgical analysis and thermocouple measurement, respectively. The first-stage rotor-blade temperature obtained by calculation and metallurgical analysis agreed almost exactly at about 2300° F. The rotor-blade temperature was higher than the stator-blade temperature at the point of failure because of the lower time constant of the rotor blade.

Figure 13. - Variation of gas and blade temperatures during failure run.
